# Massive metallosis in ceramic-on-metal bearing

Lukas Dommer, Frank Rutner, Hubert Nötzli  
Orthopädie Sonnenhof, Berne, Switzerland

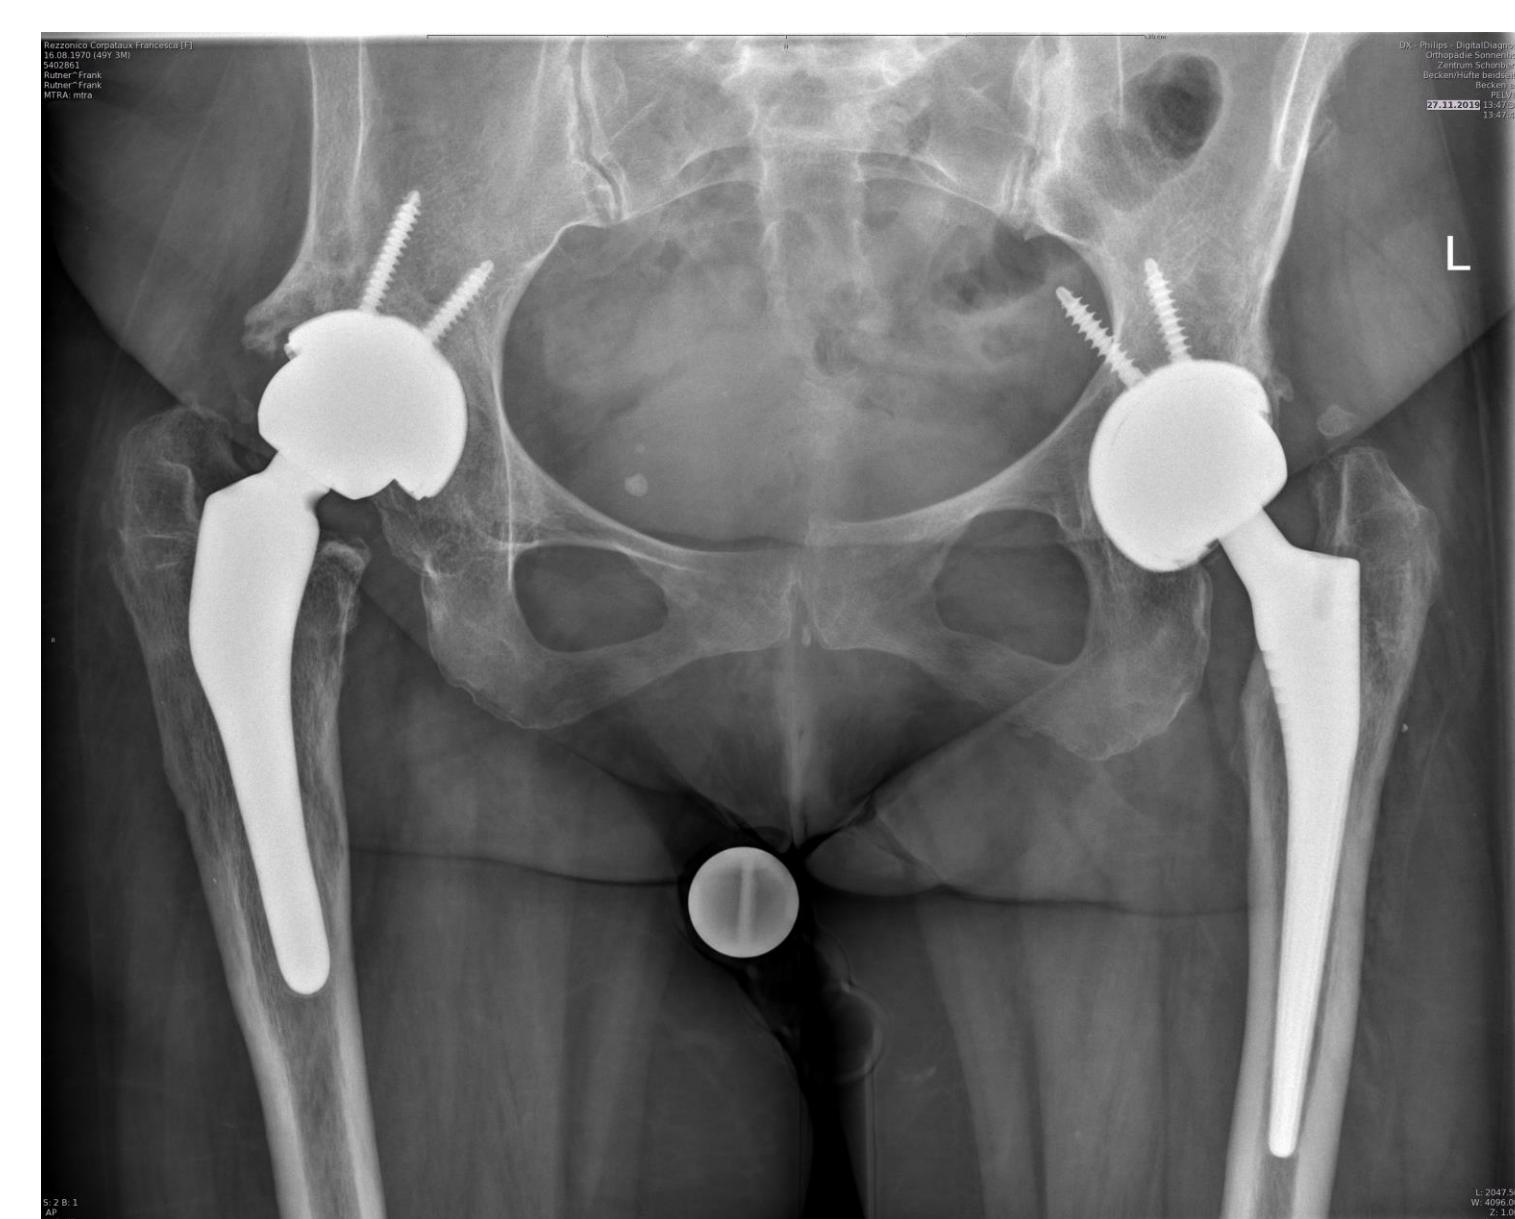
- Ambulatory only on crutches for 2 years due to right sided hip pain
  - No pain on palpation, normal range of motion, but missing abductor force
- X-ray (image 1)**
- Cup inclination 45° and anteversion of 3° was measured in a scintigraphy.

Image 1: Preoperative ap pelvis and cross table view of the right hip showing the eccentric position of the head in the cup with multiple cysts surrounding the acetabular component. Despite irregular bony appearance around the stem there was no loosening visible in the Spect-CT. The cross-table-view shows the anteriorly uncovered cup.

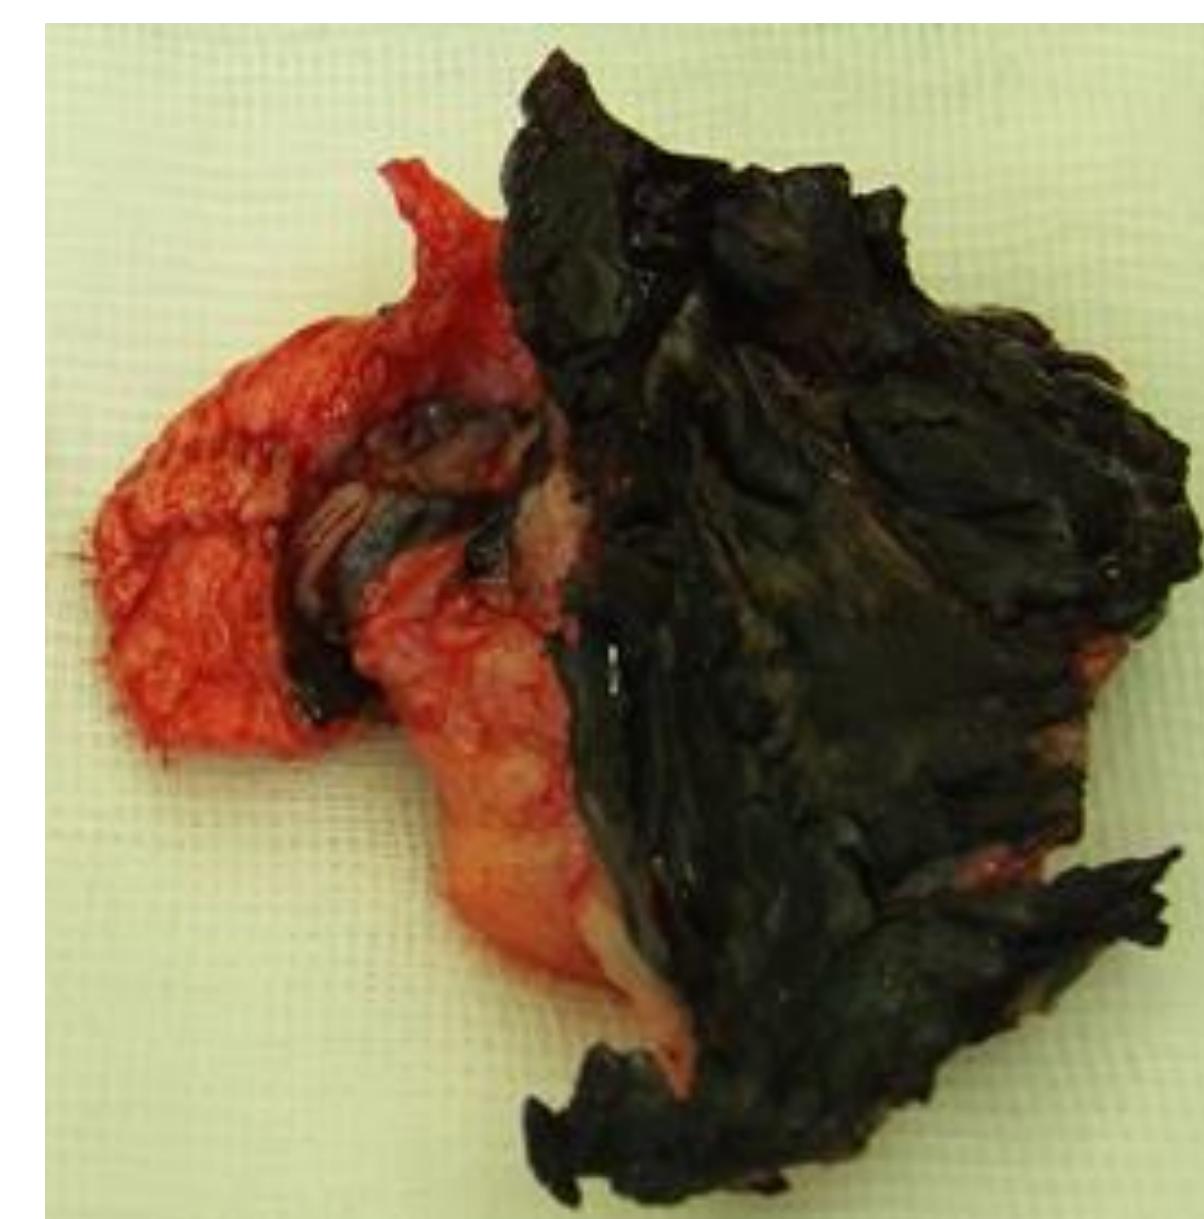
The capsule with massive metallosis was opened and resected in toto. (Image 4).

Inspection of the joint revealed that the entire anterior bony half of the acetabulum was abraded, leaving half of the metal back hanging free. Therefore, and for reasons of debridement, a complete exchange of the implants was necessary. The implants were removed, followed by a thorough debridement, preserving as much bone as possible for the subsequent acetabular reconstruction despite the alterations caused by the metallosis.

Image 4: Massive metallosis visible on debrided tissue

Reconstruction of the acetabular defect was accomplished using a shell formed out of a femoral allograft head which is held in position with an acetabular reinforcement ring with hook. The stem was replaced with a CLS stem after removal of only the most severely altered bone, particularly in the trochanteric region. This defect was also filled with allograft. The greater trochanter was re-attached using a cerclage wire and a screw.

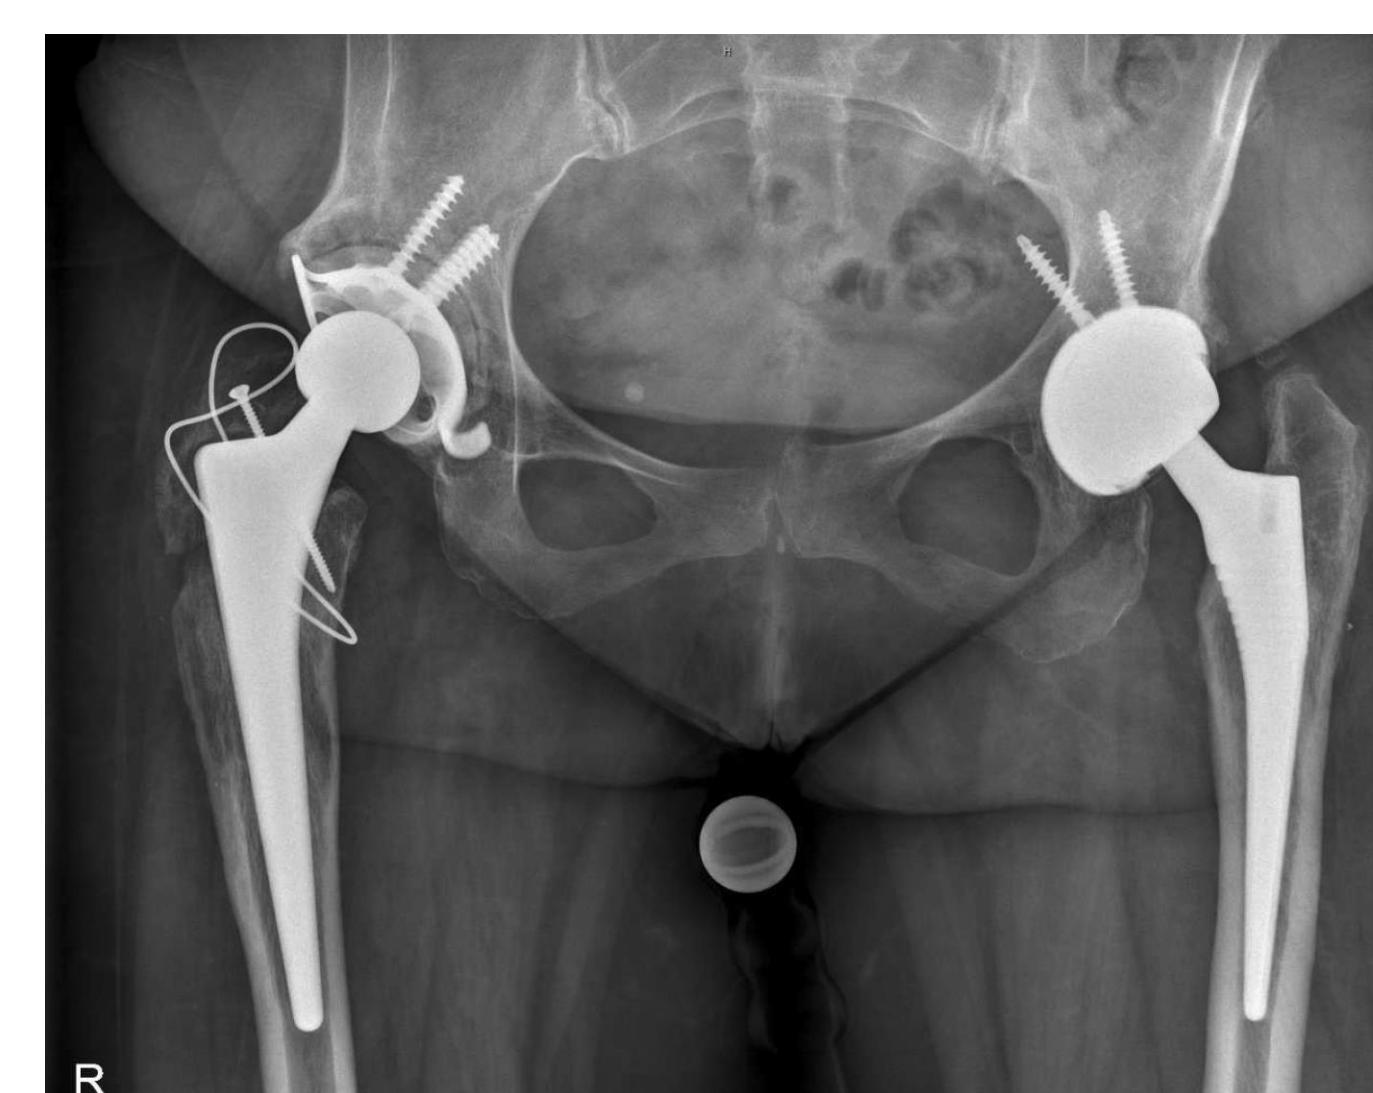
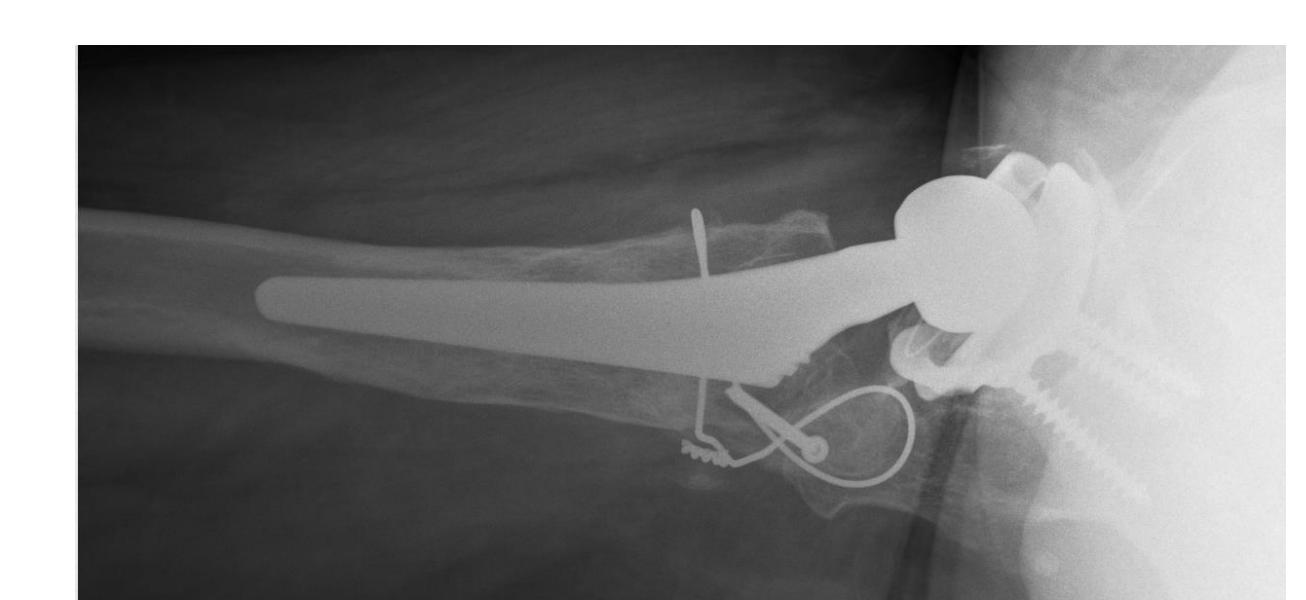
- Little to no pain
- Walking without walking aides for short distances
- Normal range of motion
- Stable implants with well visible allograft (Image 6)

Image 6: Stable cup and stem after revision surgery on the right hip.
